NACA RM E55J17

TURBOJET ENGINE INVESTIGATION OF EFFECT OF THERMAL
SHOCK INDUCED BY EXTERNAL WATER-SPRAY
COOLING ON TURBINE BLADES OF FIVE
HIGH-TEMPERATURE ALLOYS

By John C. Freche and Robert O. Hickel

Lewis Flight Propulsion Laboratory
Cleveland, Ohio

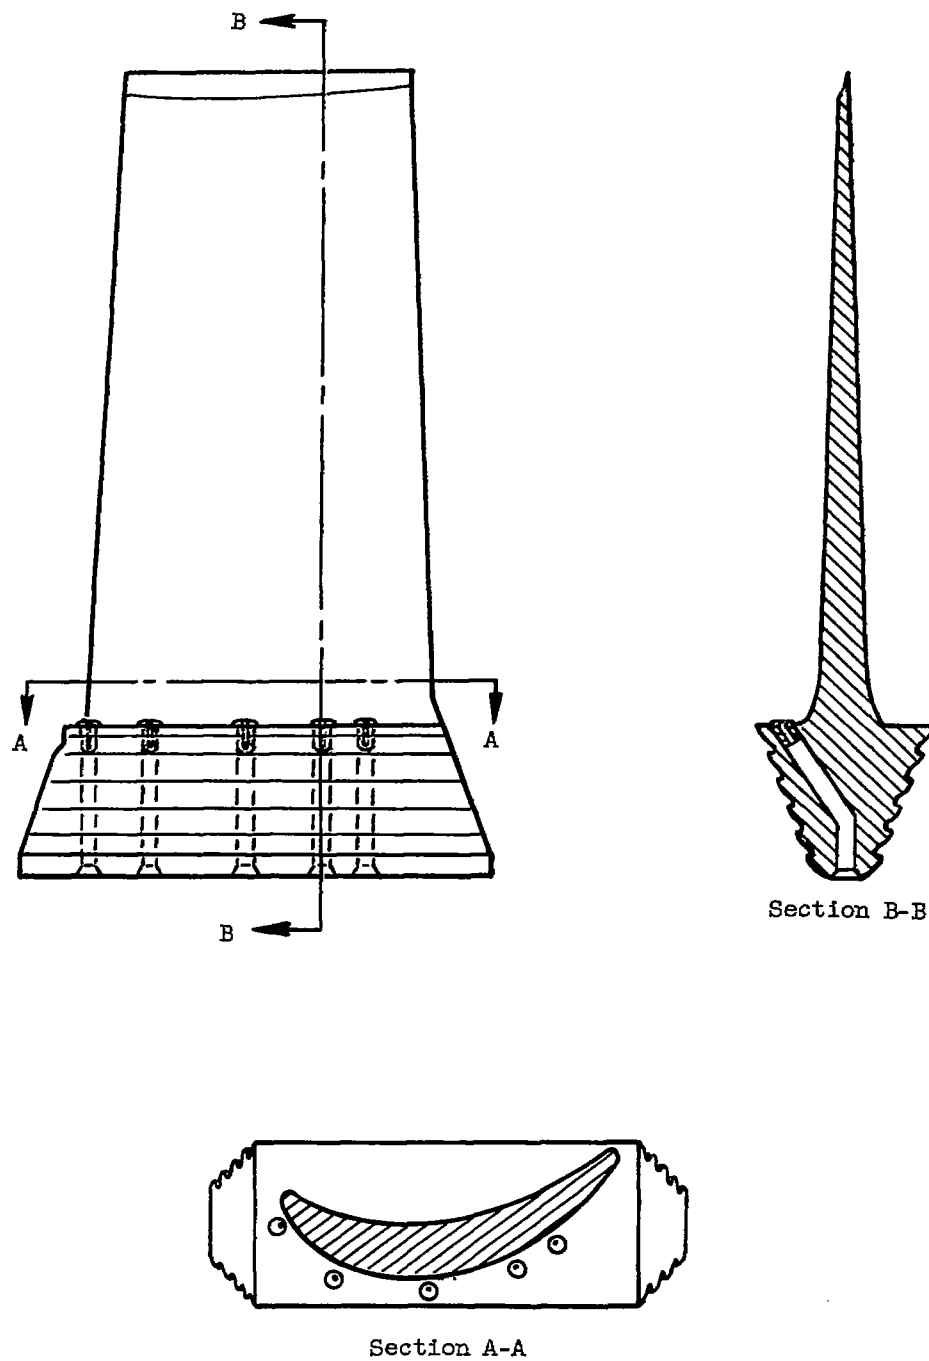
Figure 1. - Turbine rotor blade modified for water injection.

Fifty unmodified production blades of S-816 material and four test blades comprised the complete turbine rotor and blade assembly. The four test blades were of the same profile as the production blades and were modified to include five water-injection orifices in the base as shown in figure 1. The injection orifices were 0.031 inch in diameter and were located along the suction surface. Test blades of two alloys (two of one alloy and two of another) were always installed for any period of cyclic operation. Test blades were made of five high-temperature alloys. The alloys investigated were wrought S-816, Nimonic 80, Inconel X, cast HS-21, and cast Guy alloy. The first four alloys were chosen because they are commonly used in aircraft turbine blades and the thermal-shock effect of spray cooling on such blades should be known in order to evaluate aircraft application of turbine spray cooling. Guy alloy, although not commonly used, shows promise for high-temperature, high-stress applications and was therefore included.

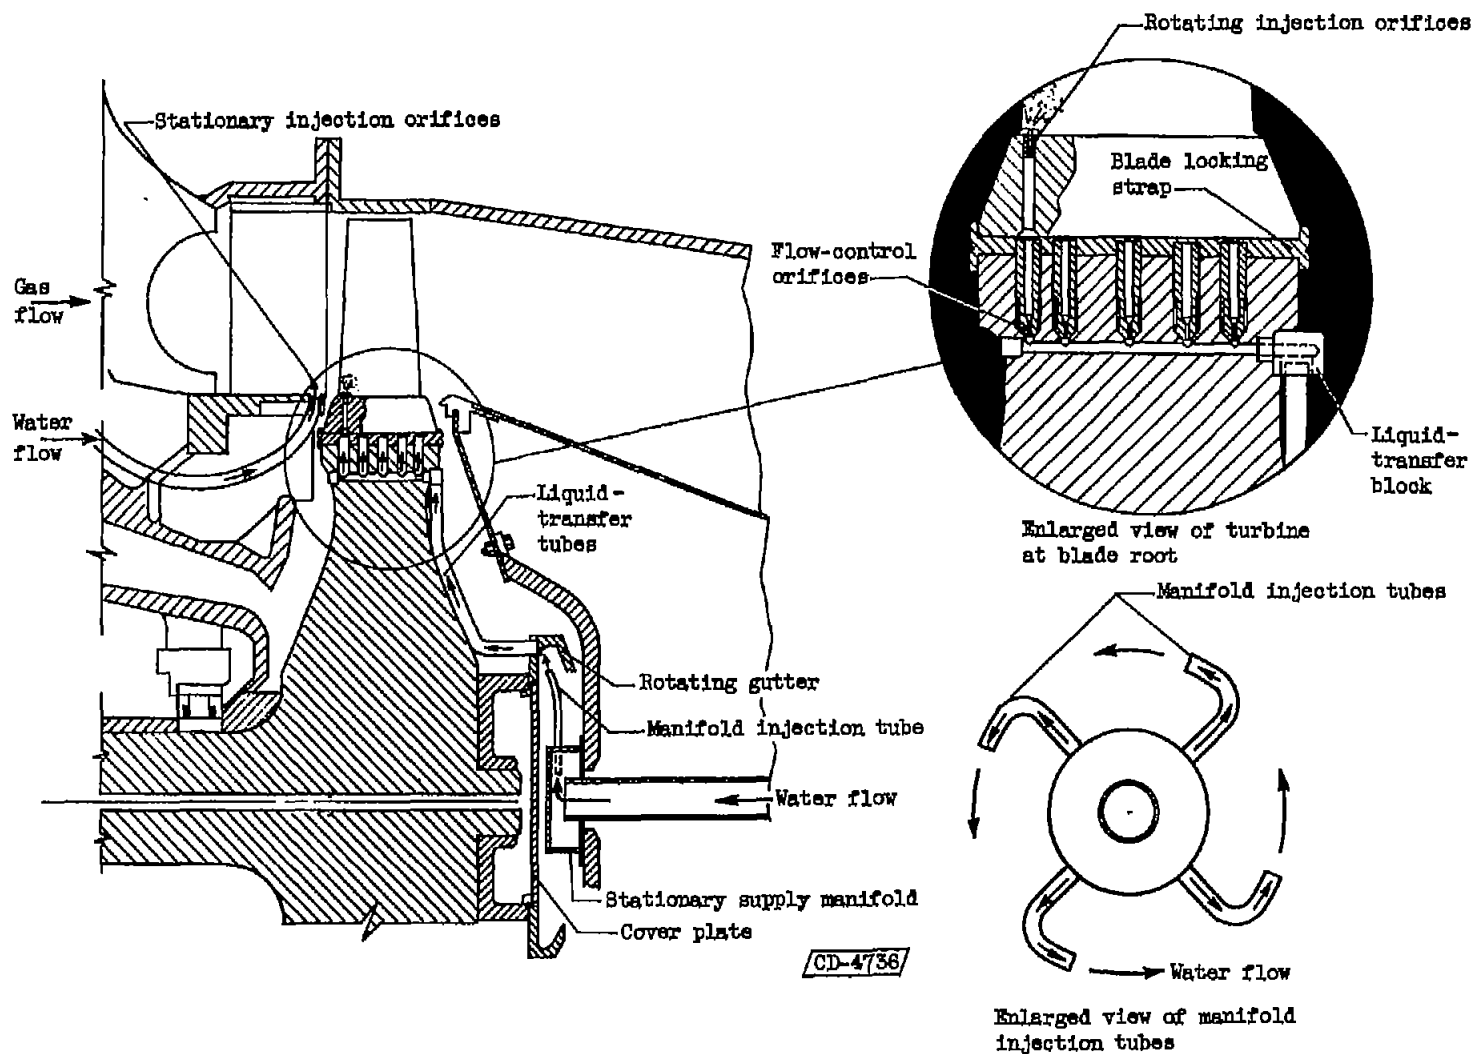
Figure 2. - Sectional view of engine showing ducts for water-spray injection from orifices located in turbine rotor blade bases and from stationary orifices in stator diaphragm.

Rotating injection system. - The rotating injection configuration employed in this investigation was one that provided nearly uniform cooling of the blade when used in conjunction with the proper stationary injection configuration (ref. 4). Various components of the rotating injection system are illustrated in figure 2 and the design details are described in reference 4. The four test blades provided with injection orifices in the blade base were spaced at approximately 90° intervals around the rim of the turbine disk. Water was supplied to a stationary manifold (fig. 2) through stainless steel tubing and discharged to the rotating gutter on the rear face of the rotor. The water then flowed radially through four liquid-transfer tubes, which were fastened to the rotor rear face, and into axial passages in the rotor rim directly beneath each of the test blades. The maximum water flow rate for any rotative speed was established by the metering action of 0.015-inch-diameter flow-control orifices located in plugs force-fitted into the rotor above the rotor axial passages. Centrifugal force on the water permitted it to bridge the slight clearance space between the rotor and blades. Water then flowed through the drilled passages in the rotor blade base and onto the blade surface through the injection orifices. In order to minimize the possibility of clogging the small flow-control orifices, distilled water was used in the rotating injection system.

Stationary injection system. - Both the location and the size of the stationary injection orifices were the same as those that provided the most uniform blade temperature distribution in conjunction with the rotating injection orifices of reference 4. The stationary injection system was similar to that employed in reference 2. Figure 2 illustrates the location of one of the stationary orifices in the inner ring of the stator nozzle diaphragm. Two orifices, 0.200 inch in diameter, located 180° apart on the inner ring of the stator diaphragm, were employed. Because of the relatively large diameter of these orifices, the probability of clogging was not great and city water was employed in the stationary injection system.
